## ROCK ROLLS – PLANT CARPETS -- MÖLLN1

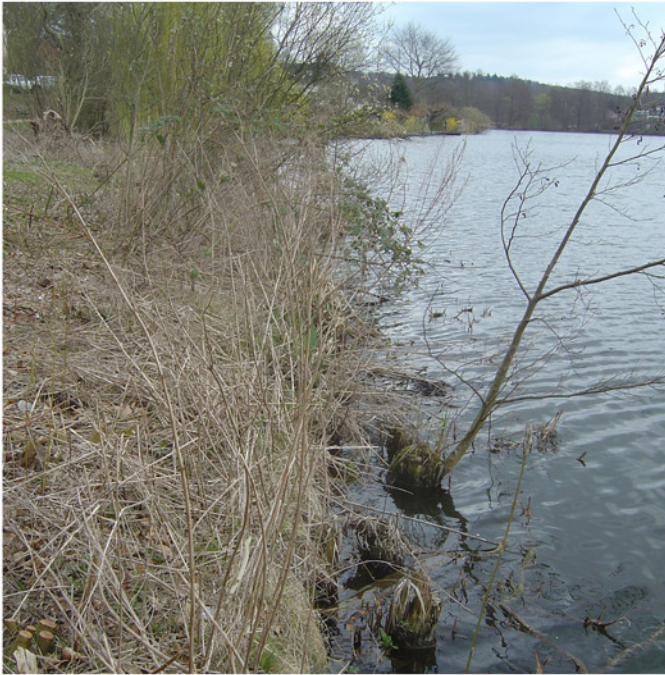
April 2007

Wave erosion caused by big wind fetches has eroded a cliff of approx. 50 – 70 cm in height. Prior attempts using sheet piling showed unsatisfactory results. Due to the high wave impact the bioengineering solution included the application of rock rolls to prevent further scouring of the shoreline.

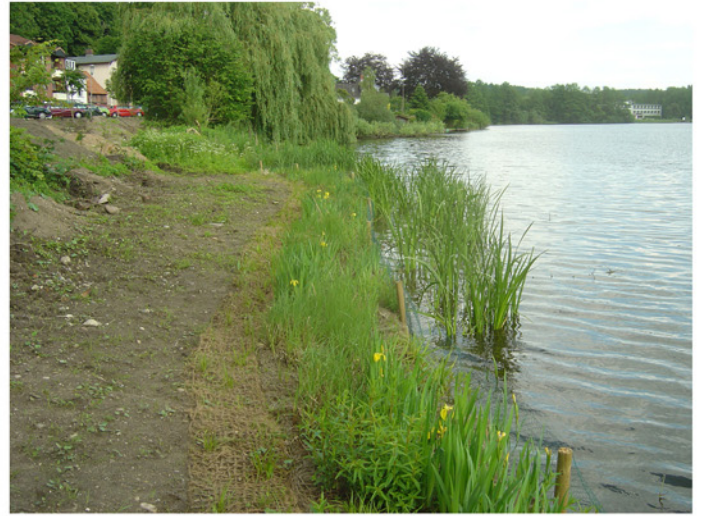
Mai 2007

The rock rolls have been backfilled and planted with plant carpets. Upslope areas have been covered with coir mesh and planted with plant plugs. The pictures below show the development three month after installation.
