Langas/Ljungby storm water basin, Falkenberg Sweden, 1998

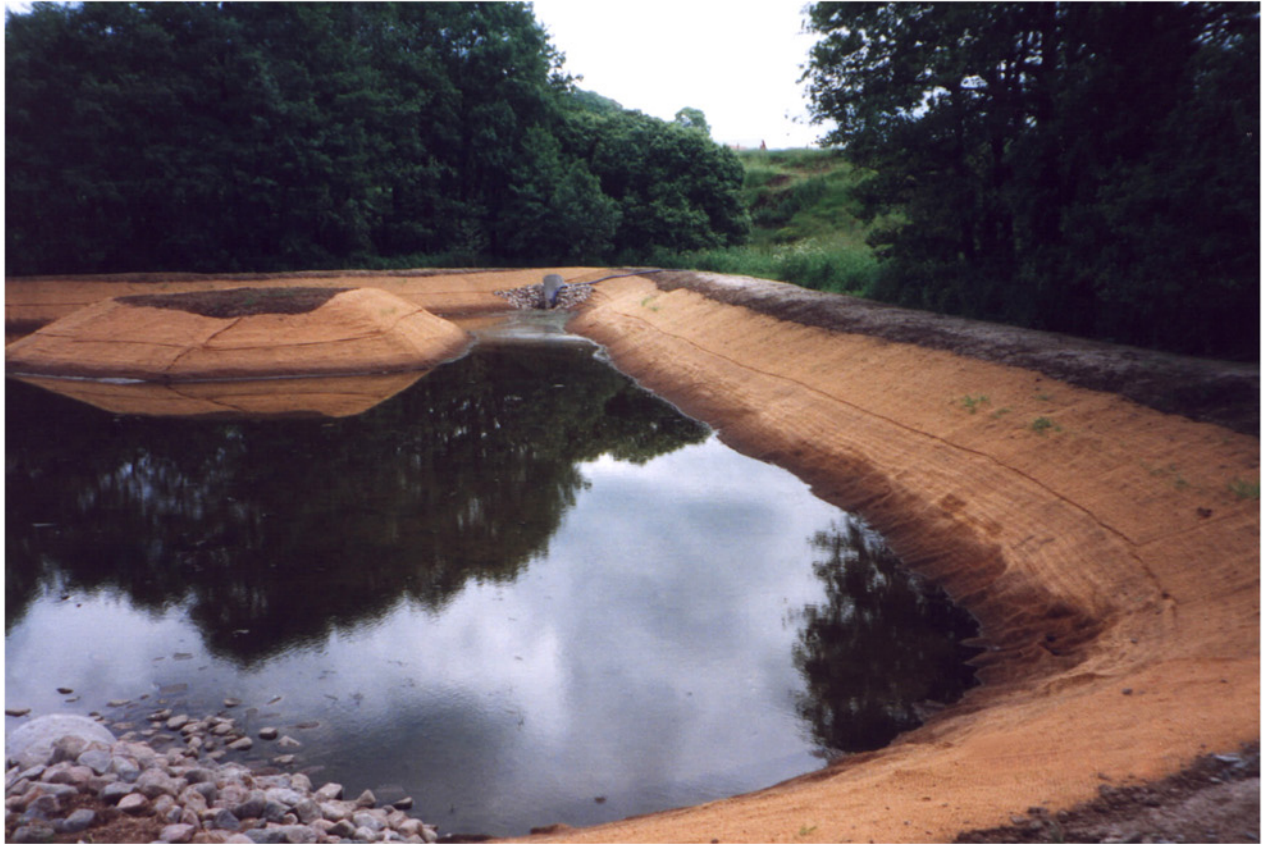
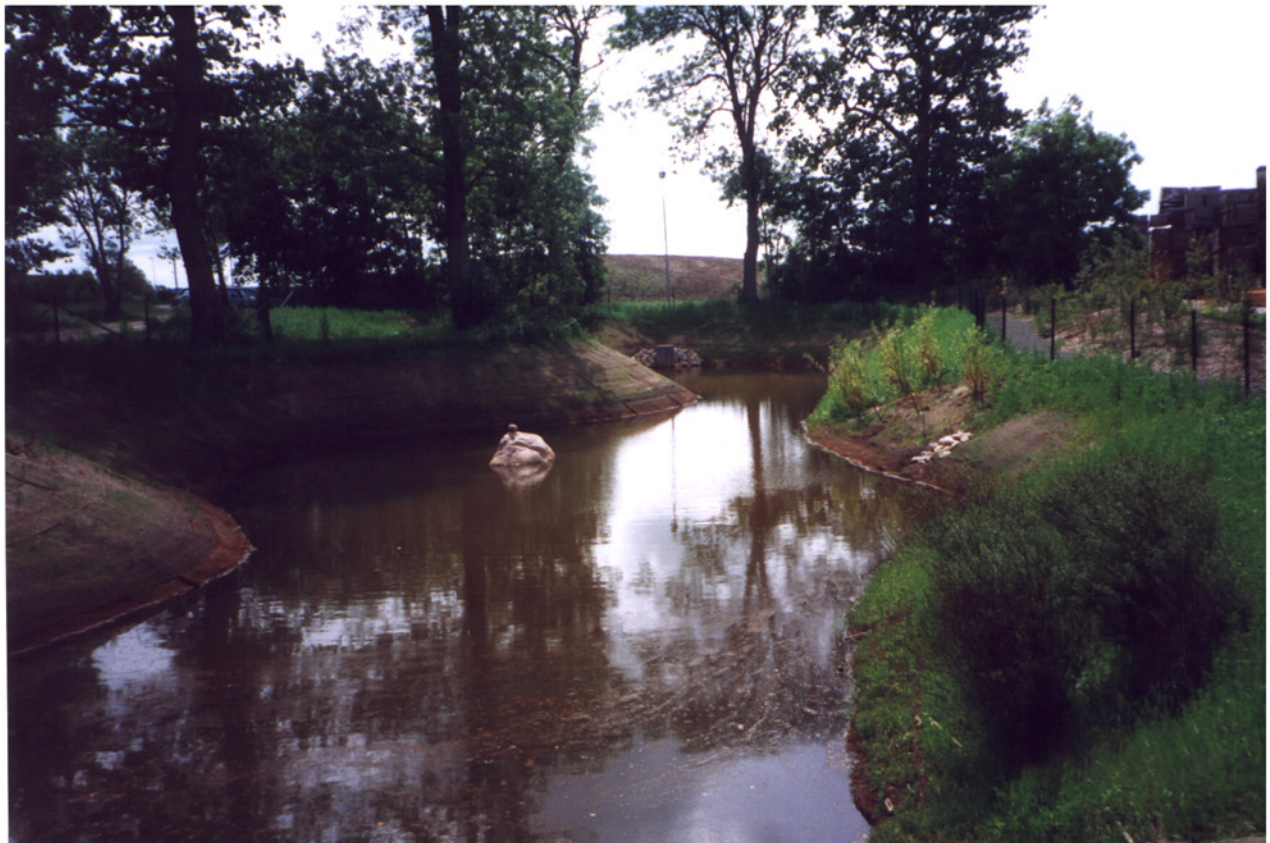
Basin for balancing storm water fluctuation in agricultural area. Sandy soil condition with great risk for erosion. Slopes covered with THULICA KK-8, coir ECB, seeded and planted.
