## Minnesund, Norway, 1993

One of Norway's highest manmade slopes with wind and rainfall erosion in sandy and silty soil. Hydro-seeding as well as traditional seeding of the slope was applied repeatedly with poor result. Tests were carried out with jute and coir geotextile with good result. Jute geotextile were chosen in areas with lower inclination and where specific water retention capacity was beneficial and coir geotextile were chosen on areas with more severe erosion.

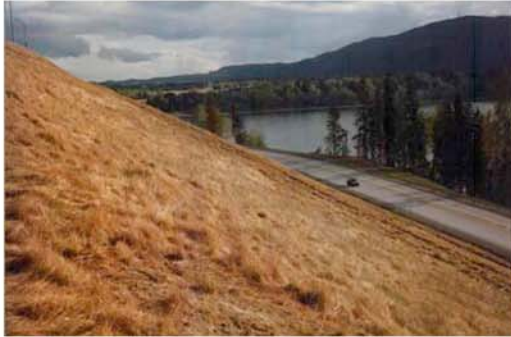
Coir geotextile

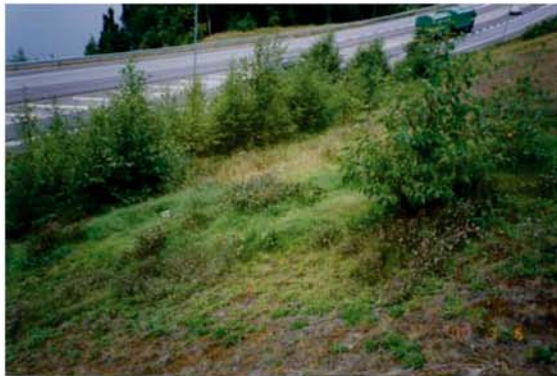
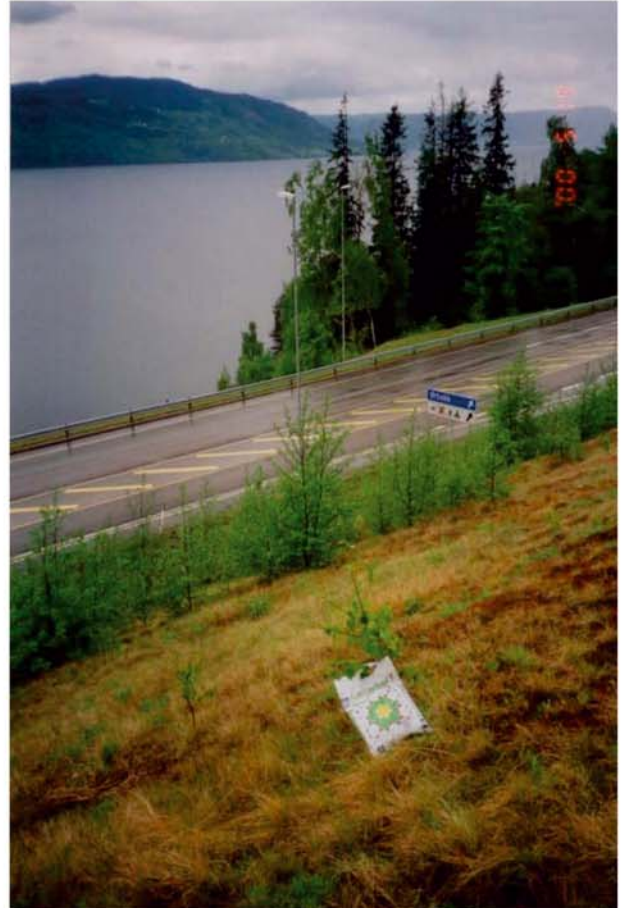
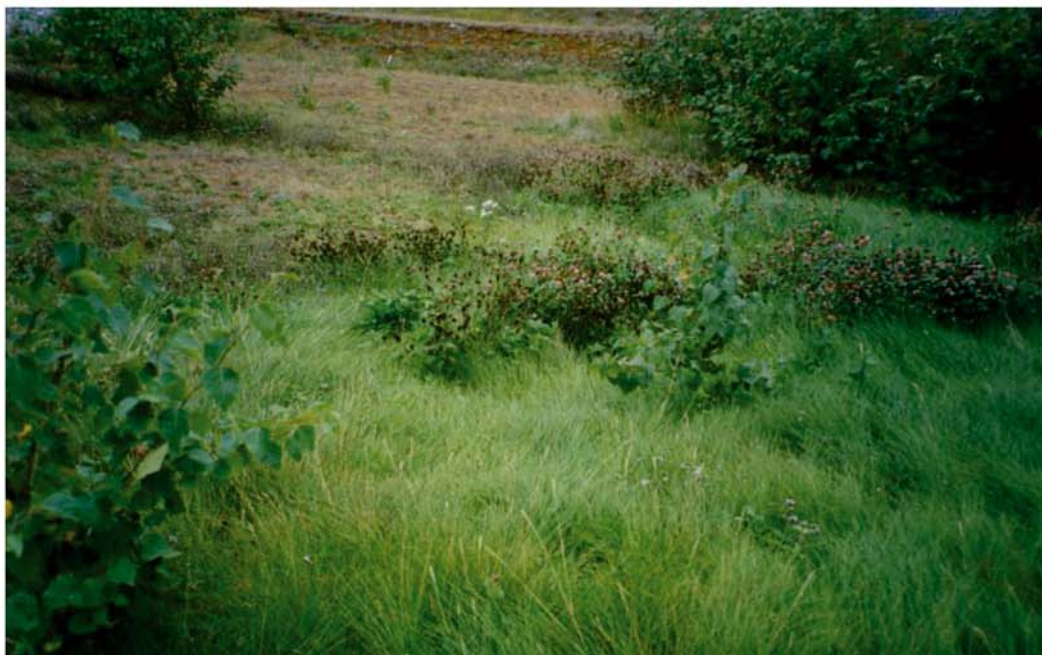
7 years later the slope shows well established and diversified vegetation
